Manhole Inspection Summary

Manhole # S55E__046MH

Insp Date: **7/21/08 10:34 AM**

Location Address: **3405 leverton ave**

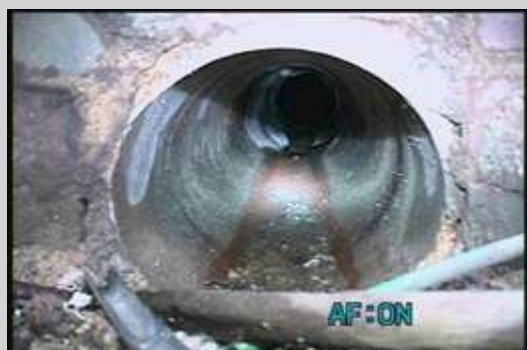
12 O'Clock Outflow

8 in. Circular Gravity Sewer
Pipe Out @ 12 O'Clock

Infiltration: **None** Pipe Seal Cond: **Unknown**
